Attachments to Appendix B

Attachment B-1

Photographic Documentation of Site Reconnaissance (2-6 March 1998)

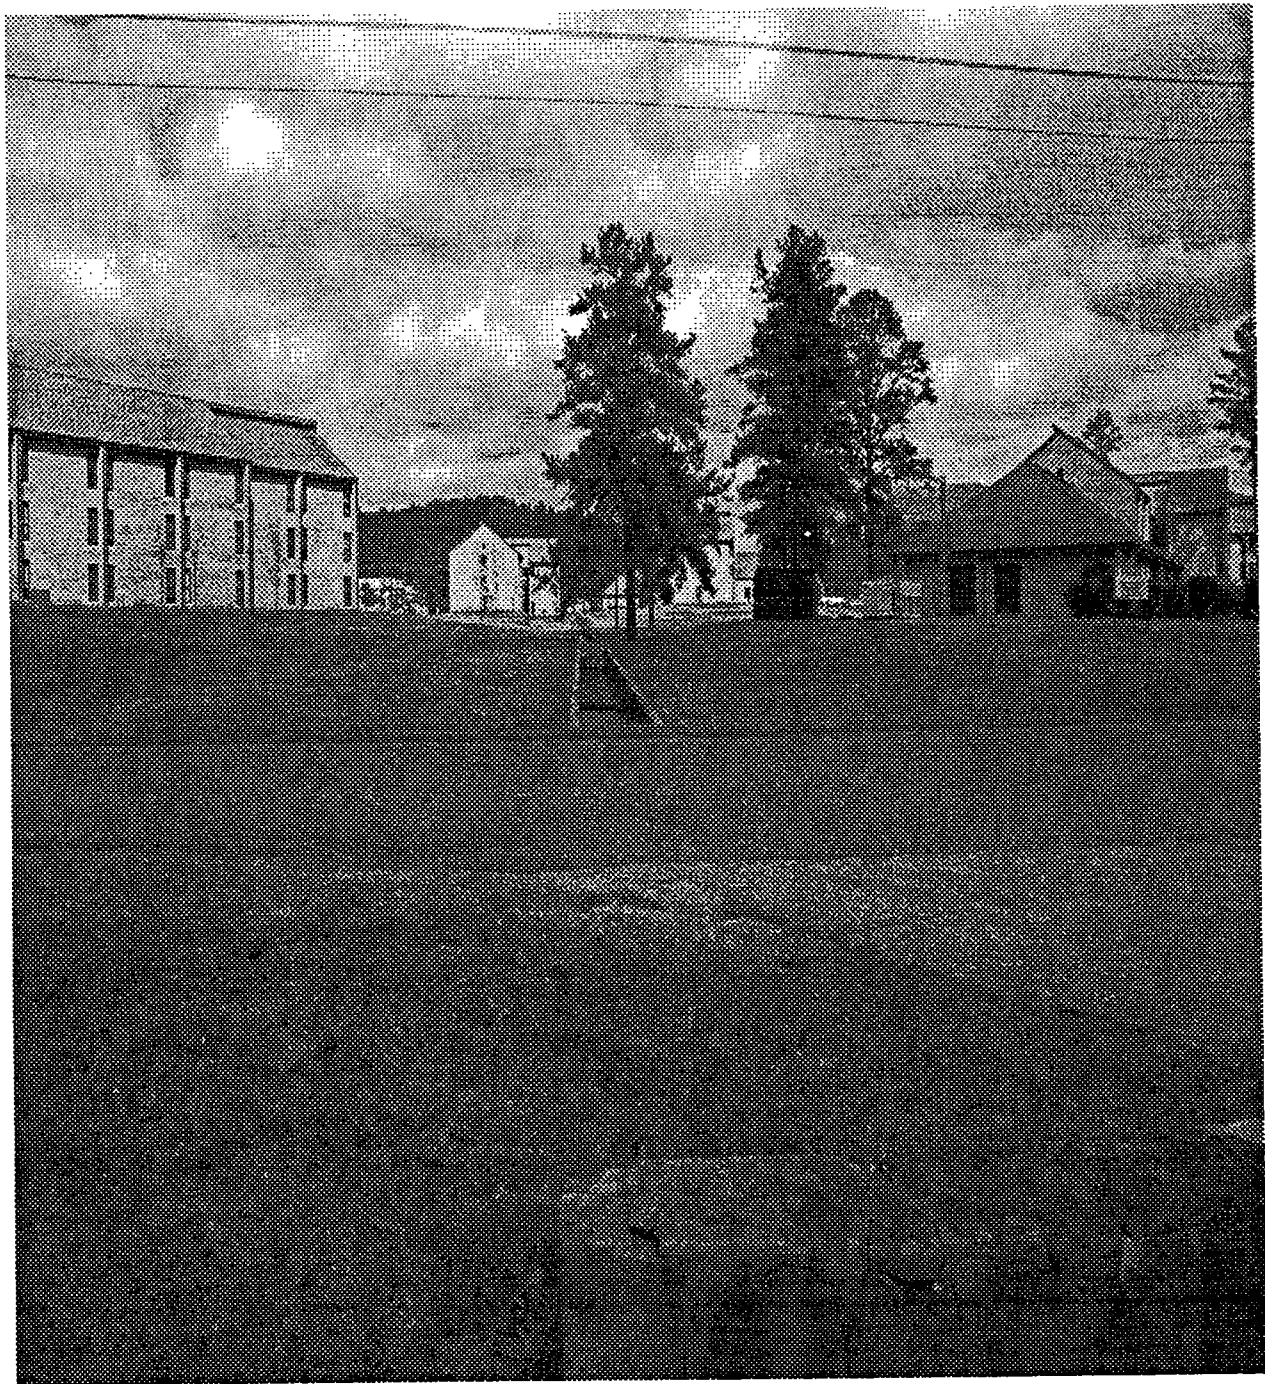
Photo A23 [3/3/98 - 1:45]

Former Hospital Area (currently an apartment and commercial office building complex) [CERFA Parcel Map: 22-23,33]

Across street to the SW of of site 95(7); photo faces NE along the visual line of the main storm channel draining the area. The channel crosses under the road via storm pipe, and continues in same direction past the viewer toward Cane Creek to the rear.

Site consists of a large, open area of maintained lawn. Single trees throughout the area were probably kept for landscaping astetics. No medical buildings remain. Drainage ditches that traverse the area are constructed concrete channels. No natural aquatic system exists on site.

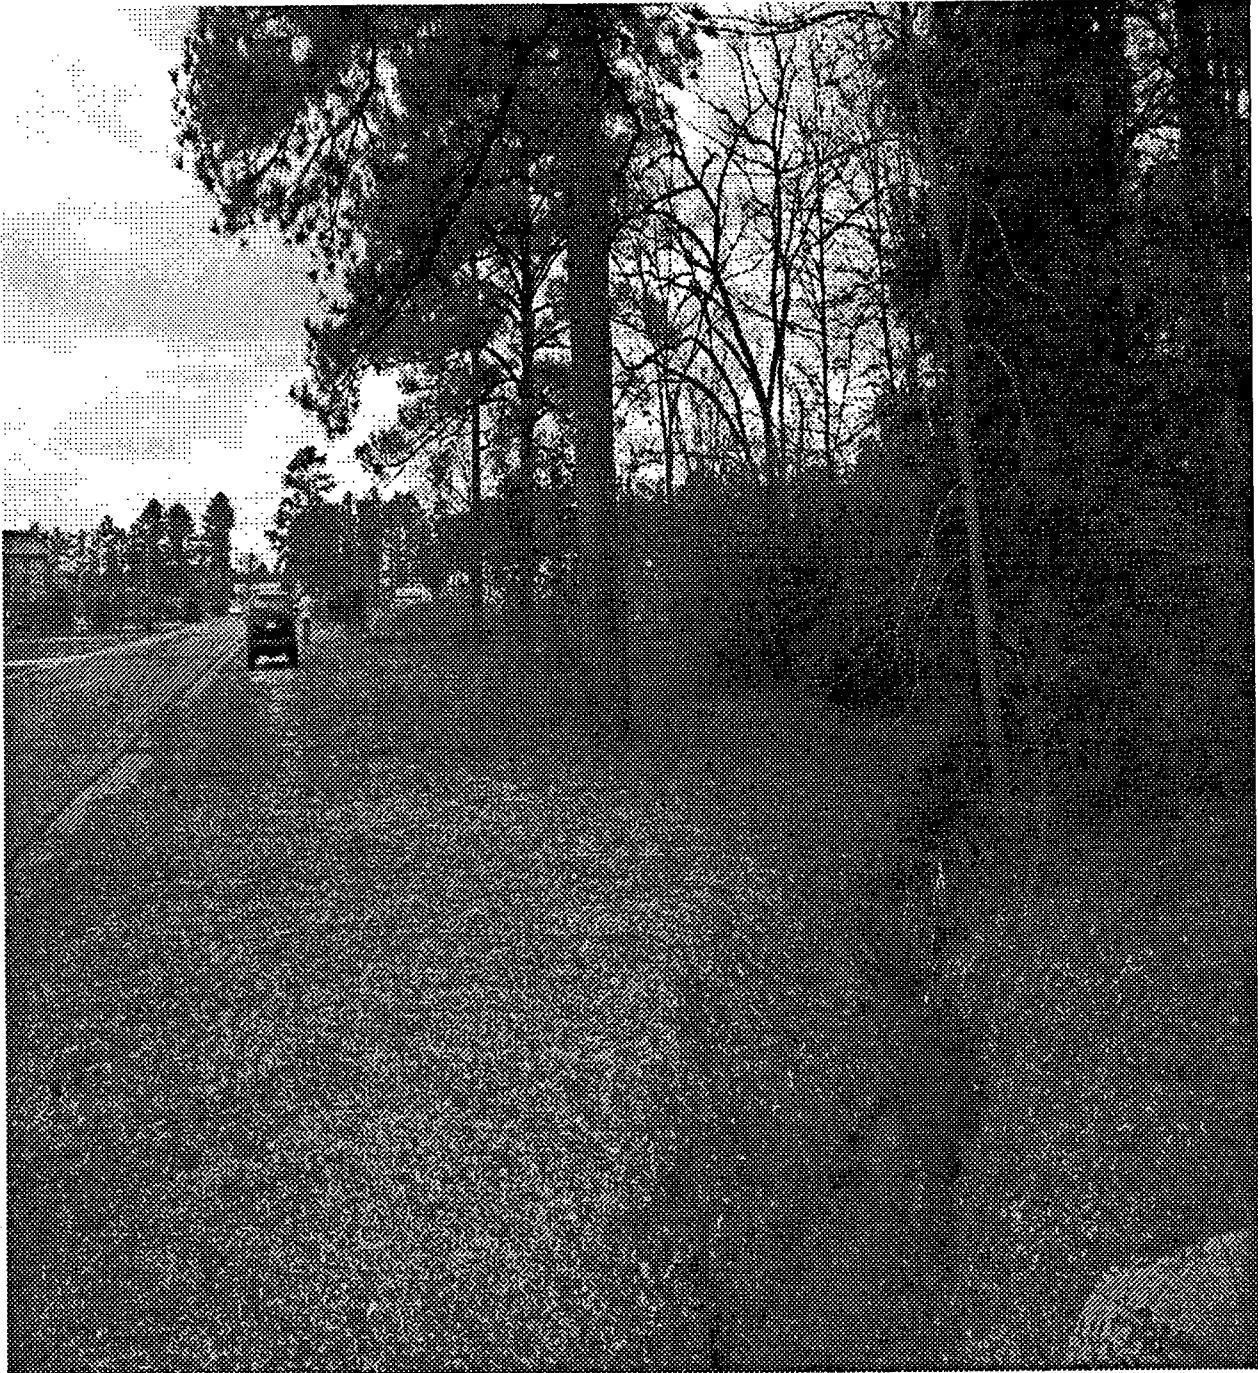
Photo A24 [3/3/98 - 1:57]

Area 800 Motor Pool [CERFA Parcel Map: 24,33}

Area Site 164(7) also contains Sites 68(7), 12(7), 11(7); photo faces N direction from the southern corner of the lot. Photo looks over a small, natural creek that runs along the SE fenceline of the lot. The SW fenceline is in the background, left of center; it runs parallel to the road on the far left of view.

The immediate area is highly altered/developed with minimal grass area within the fence. Large, open paved areas with a few structures characterize this site. Habitat on site is extremely poor. However, the area is surrounded on three sides (SE, NE, and (to a lesser extent) the NW) by unaltered, natural terrain. The small creek running parallel to the SE fenceline is natural and protected by heavy deciduous forest with thick understory.
